SAFETY ASSESSMENT
FEDERATION

In-Service Inspection Procedures

Inspection of Wellman Robey
Ygnette/Sygnette Boilers (2007 – 2016)

REFERENCE: PEC 20
ISSUE: 01.1
DATE: 08/04/2021

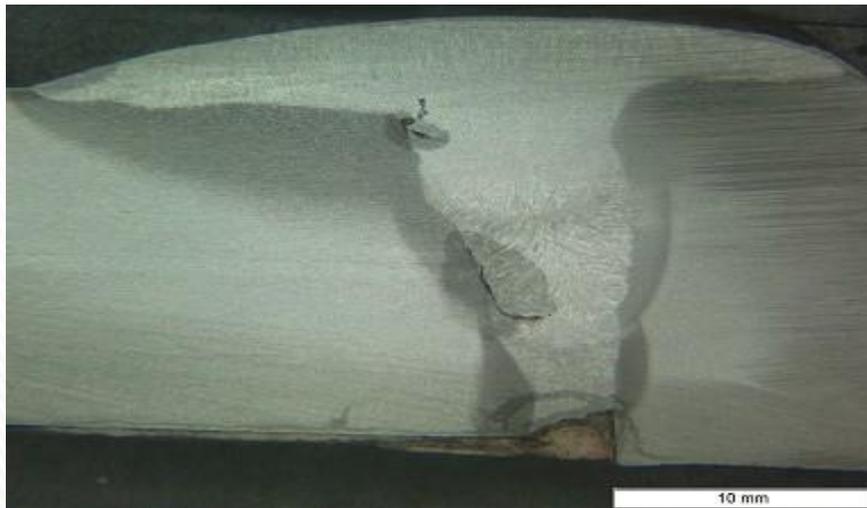
Figure 1 – Furnace Front

Defects: lack of sidewall and inter run fusion and lack of root penetration

The investigation did not reveal any evidence of any of these defects initiating cracks after five years in service, for the particular boiler under investigation. However this does not provide any assurance that the defects will not start to develop cracks in the future. Certainly the presence of the defects will undoubtedly significantly increase the probability of cracking in the future.

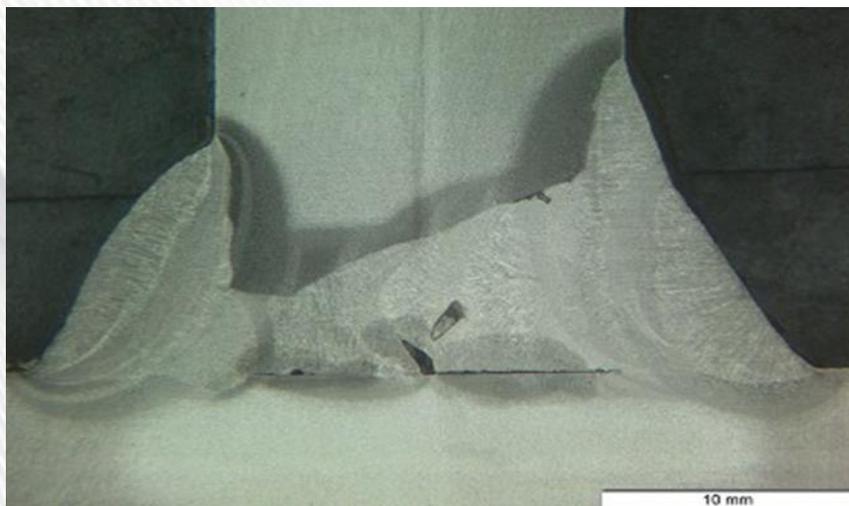
Figure 2 – Shell to tubesheet (front)

Defects: unfused land in two areas, lack of side wall fusion and inclusions
